REDUCING VIBRATION ISSUES AT SMALL VERTICAL-AXIS WIND TURBINES ON BUILDINGS

Authors: Anke Grunwald (1), Michael Melsheimer (1),
Dr. Christoph Heilmann (1, Presenter), Prof. Dr. Joachim Twele (2, 3),
Jonathan Amme (3), Norman Pieniak (2)

Company: (1) BerlinWind GmbH, Bundesallee 67, D-12161 Berlin
Tel. 030-6883337-40, -60, Fax: -69, Email: heilmann@berlinwind.com

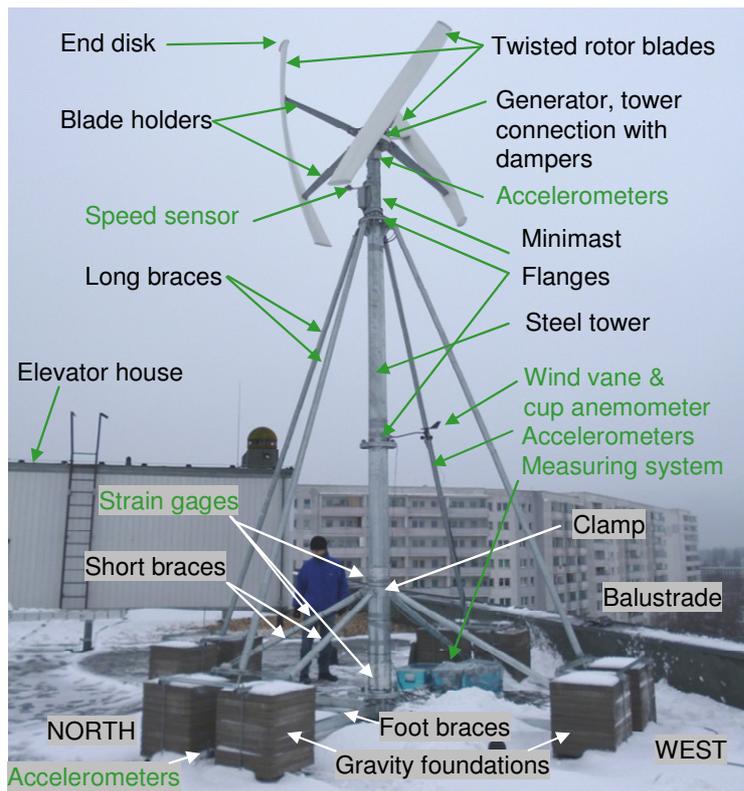
Figure 1: Vertical-axis small wind turbine Venco Twister 1000T (600 W) with 1.9 x 1.9 m rotor (older, smaller version), 6 m hub height on a Berlin roof top, tower stabilisation by long and short braces

The SWT with twisted rotor blades is shown in Figure 1. In the original configuration there are three dampers between the generator and the minimast to prevent noise propagation of rotor speed (n) dependent harmonics at $20 \times n$, originating from the 20 generator pole pairs, into the minimast and sub structure. Due to the twisted blades, the SWT starts to rotate at low winds. However, since every blade section has a different orientation to the wind, there will be an even more complicated 3D flow around each blade as for straight blades. For higher wind speeds, noise from stall effect was audible due to the blades rotating into and out of the wind every revolution.

Several variations of the tower guying were tested: All variations included the short braces, Figure 1. Instead of the shown pre-tensioned long braces, long braces without pre-tension and manually pre-tensioned guy wires were tested as well. Basically it was intended to avoid O&M costs for the periodic control of the wire pre-tension. The unexpected strong SWT and building vibrations required a detailed root cause analysis with vibration measurements to propose solutions for the issues.

The BerlinWind measurement system installed at the SWT in Figure 1 was tailored specifically for the planned measuring campaign's needs. It consisted of:

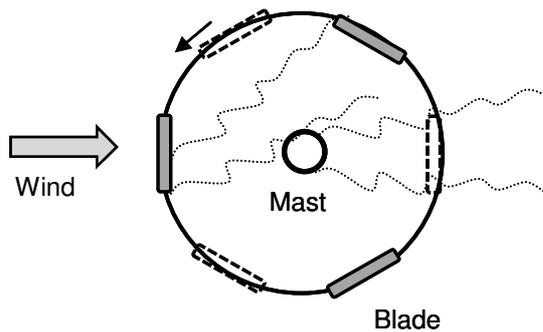
Figure 2: Schematic top view of blade-mast interaction 3 x 120° (3 x n, filled blades) and 6 x 60° (6 x n, filled and dashed blades), dotted lines: schematic wake of blade and mast

- the occurring excitation frequencies (EF) of the rotor speed and its harmonics, e.g. from blade-mast interaction, Figure 2 with
- the existing natural frequencies (NF) of the machine and structure [6, 7].

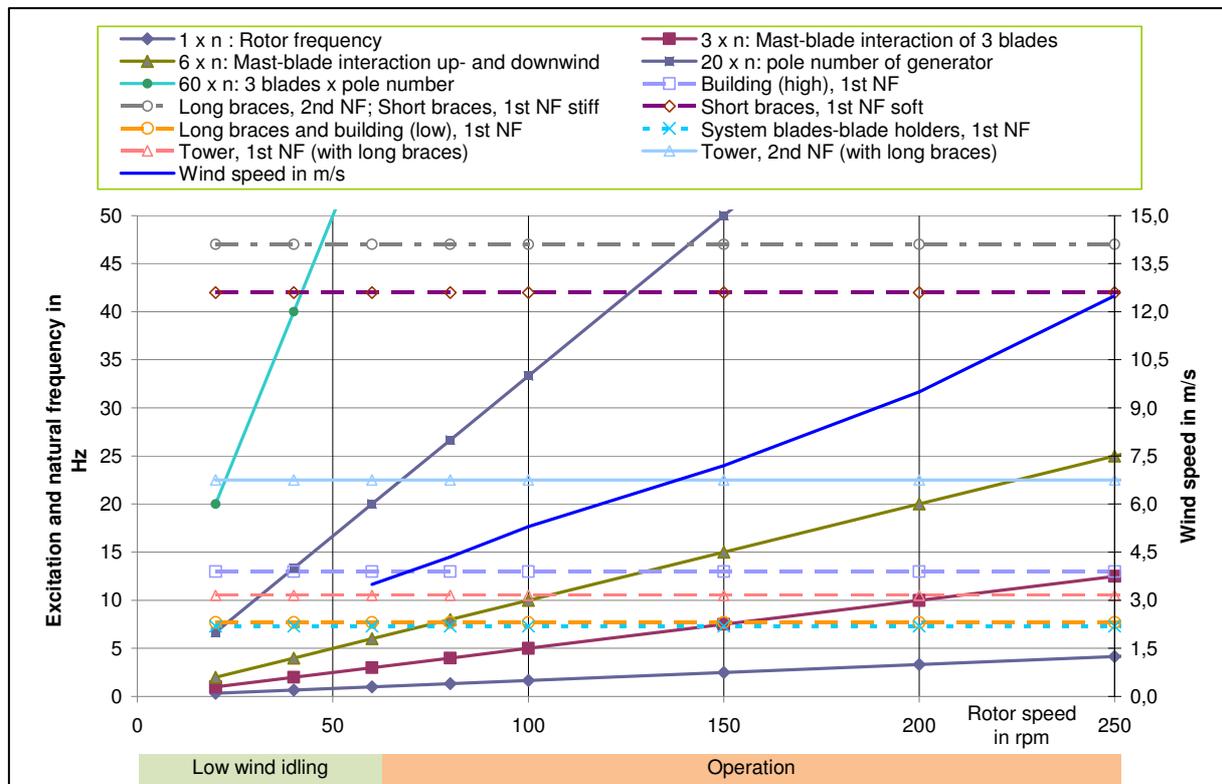
Figure 3: Campbell diagram for older version of vertical-axis SWT. Rotor speed, harmonics and natural frequencies (1st and some 2nd)

a so-called Campbell diagram, which is shown in Figure 3 and Figure 4 for the older and newer version of the SWT discussed below.

For the older SWT version with a smaller rotor and power production start at 60 rpm, Figure 3, the rotor frequency ($1 \times n$) is always below the **natural frequencies** (NF). However, there are more than 10 critical intersections of the NF with the harmonics of the rotor speed, six are already at low wind idling range. The tower's first NF is around 10.5 Hz for the structure with pre-tensioned long braces, which produces during operation resonance around 100 (resp. 200) rpm due to $6 \times n$ (resp. $3 \times n$). For the building's NF, two lines are drawn, at 7.7 and 13 Hz, for different buildings showed different natural frequencies.

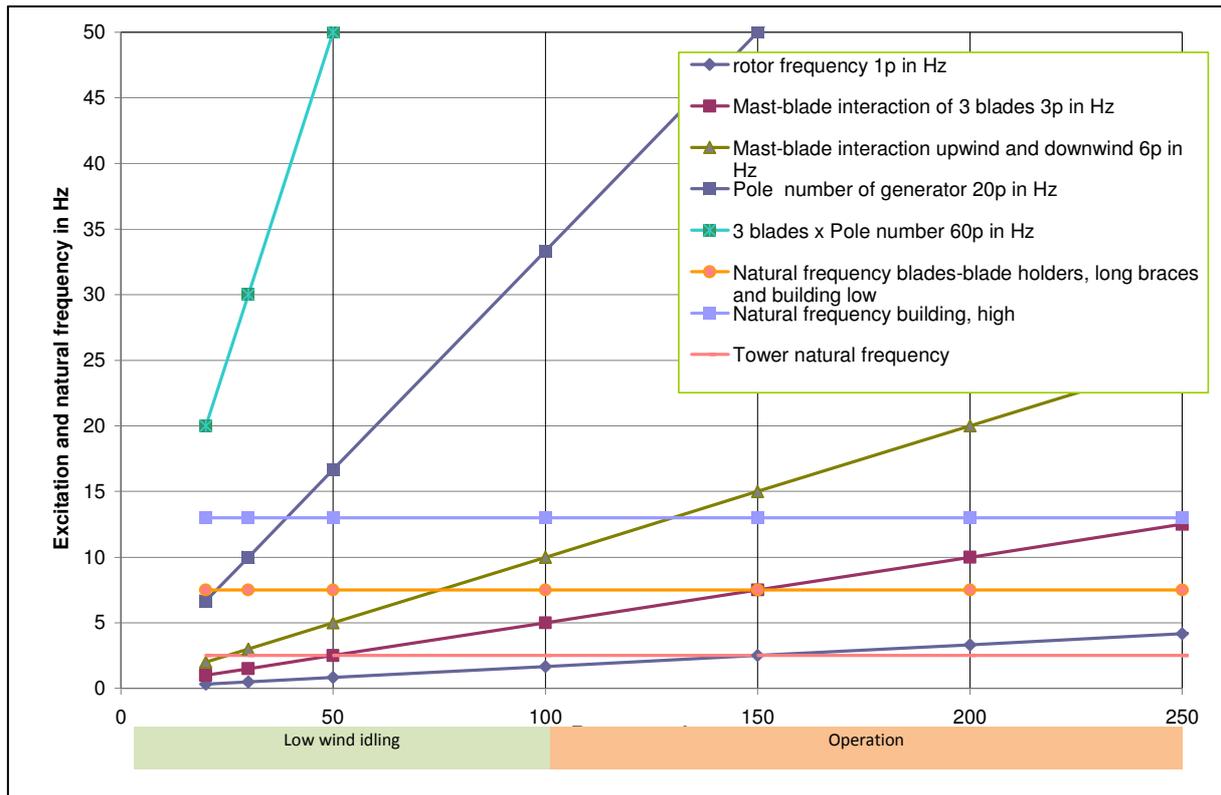
Figure 4: Campbell diagram for newer, larger version of the vertical-axis SWT with similar tower structure. Rotor speed, important harmonics and some 1st natural frequencies. For newer version resonance issues already at low wind idling

In contrast to that, for the **variable-speed WT**, the entire operating range from low wind idling to maximum rotor has to be considered in the Campbell diagram, Figure 4. The rotational frequency and its harmonics give the curves linearly increasing with the rotor speed. The natural frequencies are mostly independent of the rotational speed, therefore they are horizontal lines. Every intersection of an excitation curve with a natural frequency line is a critical point where structural resonance occurs and leads to strongly amplified vibrations if the WT runs for a longer period at this operating point. In the following, the resonance issues more specific to the investigated SWT are described.

For the newer, larger SWT version and power production start at 100 rpm, Figure 4 bottom, more resonance issues appear already during low-wind idling with the natural frequency of the long braces of the SWT, and some of the buildings, which are excited by harmonics. Figure 5 shows for the older SWT version horizontal **acceleration amplitudes** measured at the minimast (LC: blue and AX: red) and at a long brace (LP: green) during operation

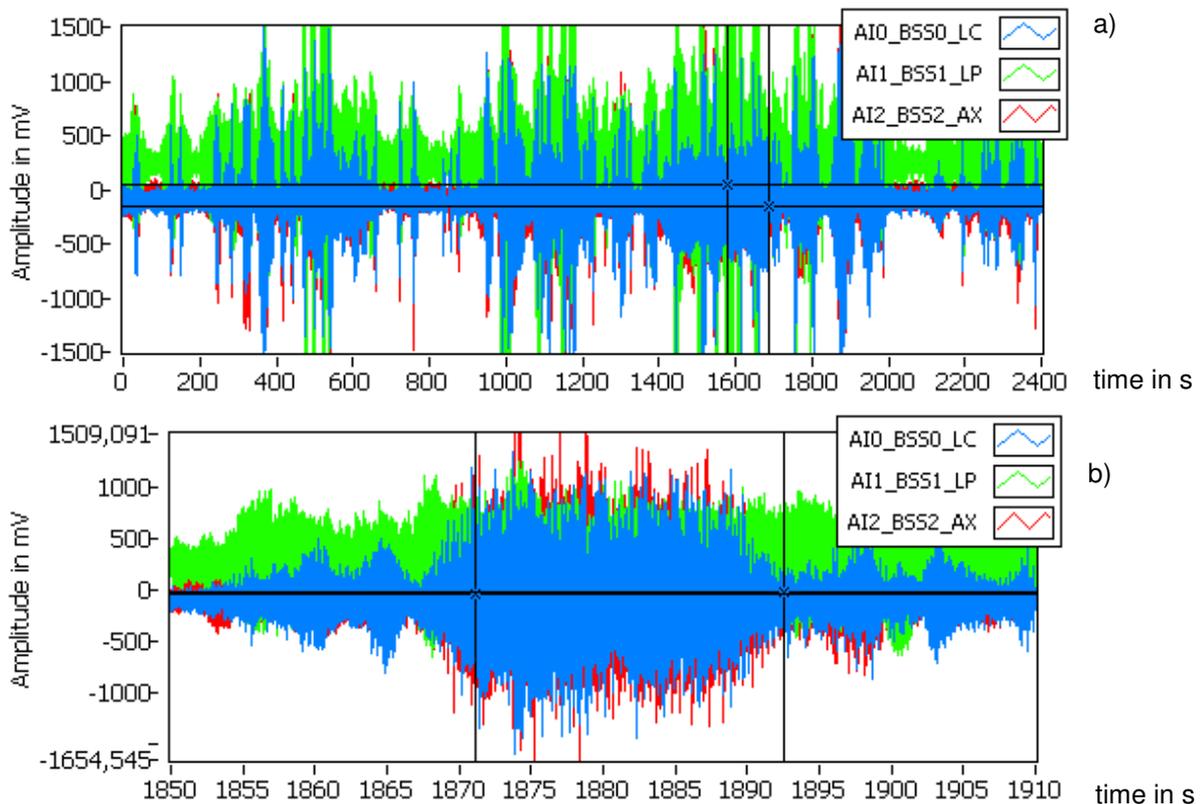
Figure 5: 40 min measurement under operation with $n=80$ to 220 rpm at older version of SWT: a) Horizontal acceleration signal at minimast (LC, AX) and at middle of long brace (LP) with heavy horizontal vibrations exceeding $\pm 1 g$ (unit: $1 \text{ mV} = 1 \text{ mg} = 1/1000 g = 1/1000 * 9.81 \text{ m/s}^2$); b) detail: heavy vibration amplification due to resonances at rotor speed above 180 rpm

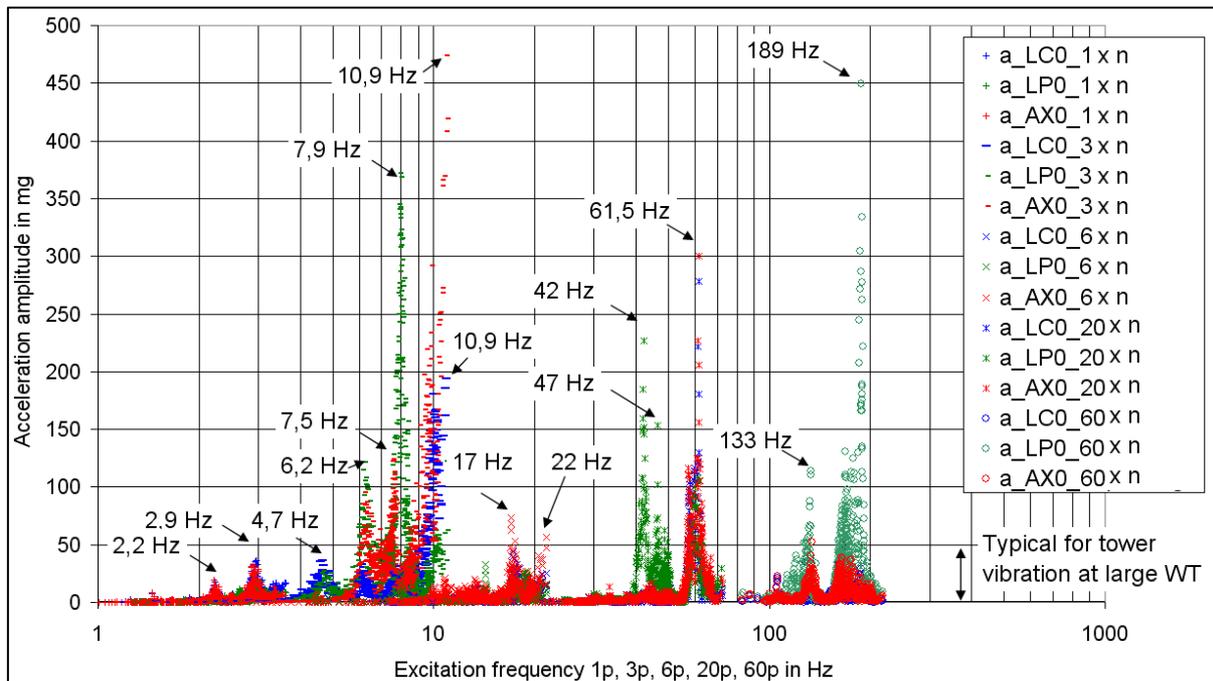
Figure 6: Acceleration amplitude versus excitation frequency for rotor speed range $n = 30$ to 220 rpm obtained by order analysis using sliding window size of 8 revolutions. Longer measurements at minimast and long brace for the older SWT version. Various resonance issues due to rotor speed harmonics and natural frequencies marked. Unit: $1 \text{ mg} = 1/1000 \cdot 9.81 \text{ m/s}^2$

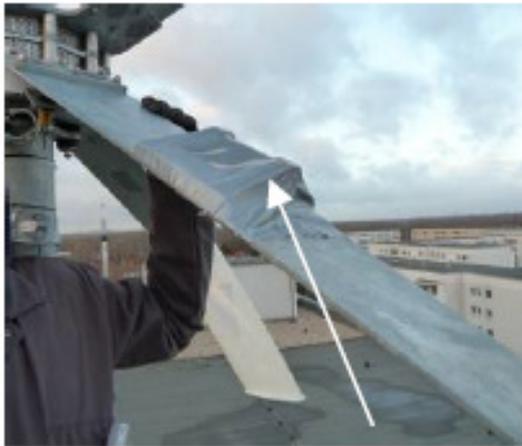
Figure 7: Test masses temporarily fixed at the blade holders for 2-plane balancing measurement at older SWT version

Due to the axial length of the vertical SWT rotor, only **two-plane balancing** is the appropriate method to determine the MI in the upper and lower rotor section. For calibration temporal test masses had to be taped to the blade holders, Figure 7, or realized by nuts and washers at the blade bolts for the newer SWT version. Due to the strongly fluctuating wind and rotor speed, Figure 8, there are only very short periods with a suitably low rotor speed standard deviation during a measurement run.

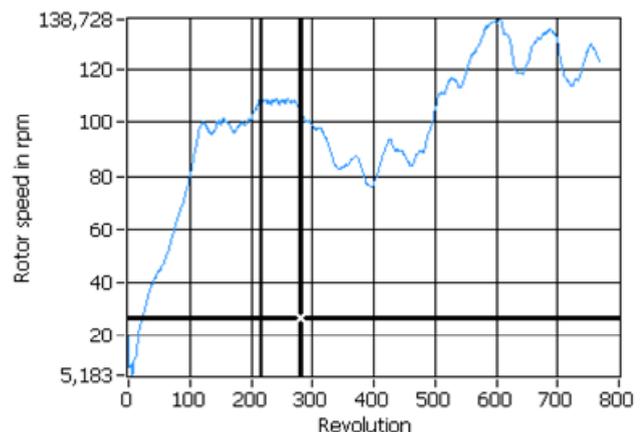
Figure 8: Rotor speed versus recorded revolution: Typical rotor speed fluctuations during rotor balancing measurement with only small section of nearly constant rotor speed (approx. 108 rpm) suitable for balancing evaluation

All balancing evaluations have to be done for the same rotor speed (here 108 rpm) and with the same speed standard deviation, because the centrifugal forces from imbalance depend on the squared rotor speed. The measured amplitudes are influenced in addition by the frequency ratio of rotor and natural frequency. If this is not observed, speed variations falsify the balancing result. Since it is unknown how strong the wind will be in the next runs, a quite long measurement time is needed. Therefore, balancing SWT takes as much time as for large WT.
